# RECONSTRUCTION OF HIT-AND-RUN VEHICLE TYPE BASED ON UN-COMMON RUN-OVER INJURIES

## ABSTRACT

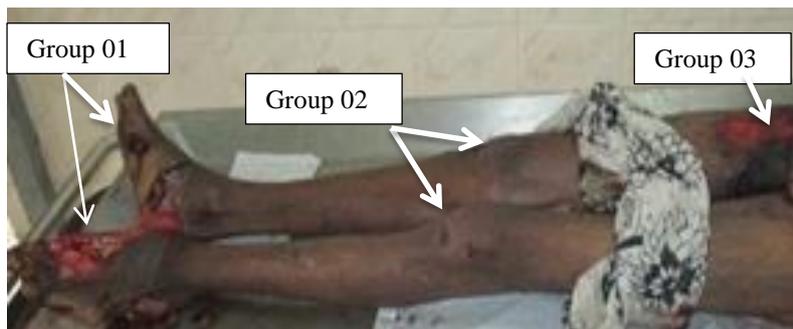
Autopsy revealed that the body was clad in a sarong and a long sleeved shirt and the clothes had dust and mud stains but no tire marks. There were no paint or glass fragments in the clothes and the body. There were three groups of injuries (Figure 1); transversely placed crushed lacerations and underlying fractures in feet (Figure 2), almost transversely placed elongated large

crushed laceration over the pubic area of the pelvis with underlying major vessels damage including right femoral vessels. (Figure 3), and superficial abrasions over knees (Figure 4). Distance from feet to knee injuries was 23 inches and to pelvic injuries 46 inches.

**Figure 1: Three groups of injuries**

Two areas of crush injuries placed transversely over feet and pelvis with almost injury free area in-between suggest run-over by two tires. Therefore, run over by a motor bike could be safely excluded.

The distance between the two crushed injuries was 4 feet and it suggests that the offending vehicle could be a less wide vehicle rather than a van or standard compact car where the width is usually about 5.6 feet<sup>5</sup>. The distance between the rear wheels of a standard three wheeler available in Sri Lanka is 4 feet.

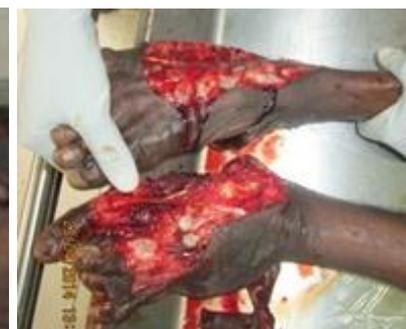
**Figure 2: Crushed feet**

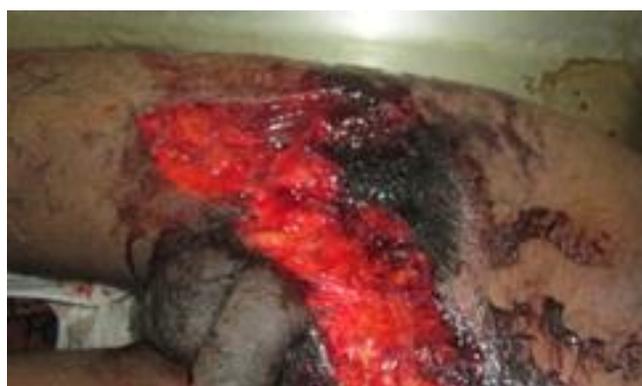
**Figure 3: Crushed laceration over the pelvis**

Absence of underlying pelvic fractures or severe internal organ damages were more compatible with wheels of a light vehicle such as three-wheeler rather than a supermini, subcompact<sup>5</sup> or light car such as Maruti 800 where the width of wheels is about 4 and half feet (56 inches)<sup>5</sup>.

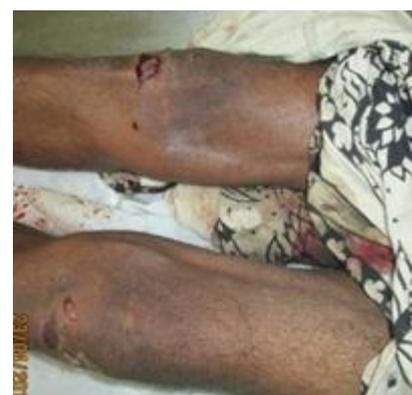
**Figure 4: Superficial injuries on knees**

Injuries over knees were not severe and were situated midway between the two severe injuries and were compatible with front tire of a three-wheeler. Less severe injuries by

front tire could be due to less weight exerted on it.
